**DEPARTMENT OF TRANSPORTATION**

Contract #: 04-0120F4Cty: SF/ALA Rte: 80 PM: 13.2/13.9File #: 01.28**WELDING INSPECTION REPORT****Resident Engineer:** Casey, William**Address:** 333 Burma Road**City:** Oakland, CA 94607**Report No:** WIR-029965**Date Inspected:** 27-Aug-2013**Project Name:** SAS Superstructure**OSM Arrival Time:** 700**Prime Contractor:** American Bridge/Fluor Enterprises, a JV**OSM Departure Time:** 1730**Contractor:** American Bridge/Flour Enterprises, a JV**Location:** Job Site

**Bridge No:** 34-0006**Component:** See Below**Summary of Items Observed:**

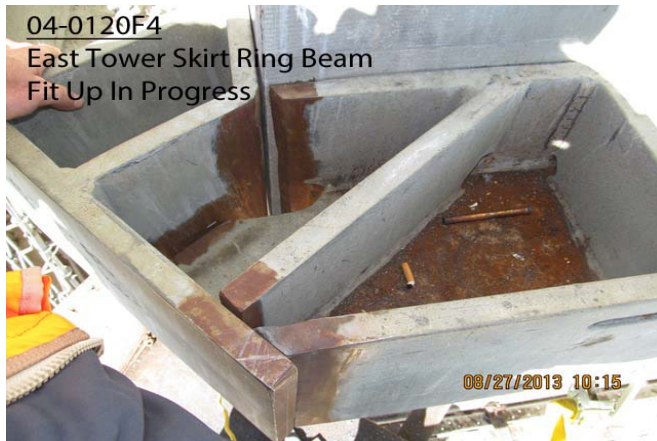
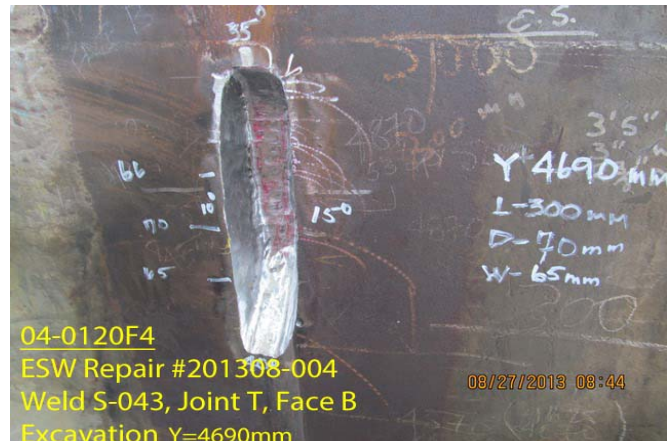
ESW S-043, Location "T" Face B

The QAI observed ABF welding personnel Mike Jimenez performing excavations in two locations of ESW "T" Face B @ Y=4690mm & Y=4100mm to verify indications observed during Ultrasonic Testing pulse/echo & pitch/catch. Mr. Jimenez was performing the excavations using an air carbon arc gouging and a grinder. Mr. Jimenez was instructed by QC Inspector Jesus Cayabyab to notify him when indications were visible to allow time for QC/QA to inspect the excavation and perform informational Magnetic Particle Testing (MT) examination. The QAI was informed by QC Inspector welder visually identified slag in both excavations. QC Inspector instructed welder to clear indications and grind the excavation with a dye grinder.

Excavation #1 Y=4690mm~4990mm, Depth=70mm, Width=65mm. Excavation #2 Y=4100mm-4410mm, Length=310mm, Depth=70mm, Width=68mm. The QAI and the QC Inspector performed MT inspection of the ground excavations to verify removal of indications. No relevant indications were noted.
